PROJECT SNAPSHOT

ISS/ISCO at Small Former Dry Cleaners

Location: Seattle, Washington

Reagent: Klozur SP & Sodium Hydroxide

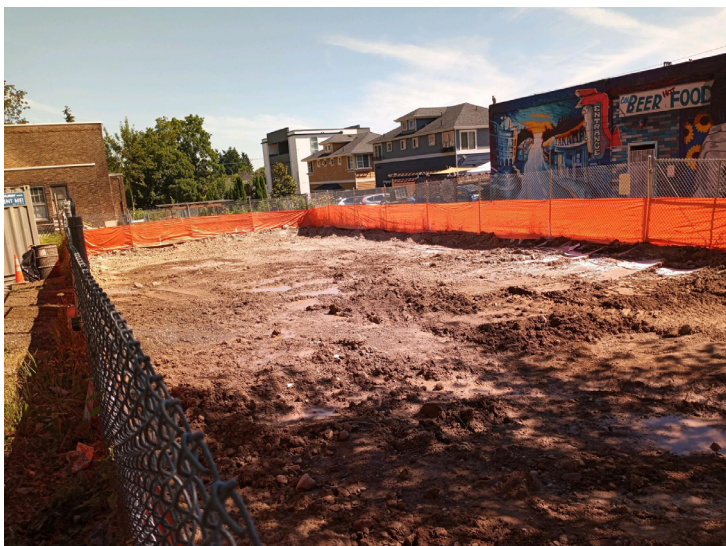
The site was very small, within a mixed residential and small business neighborhood. Field crews had to be extremely cognizant of surroundings, to minimize noise, dust and traffic impact on the neighborhood. Since both the work site and mixing area were limited, a stand-alone batch plant on site for the Portland cement was not feasible. The field crew coordinated with a local cement supplier to deliver pre-mixed and appropriately sized loads cement since the area provided minimal storage and pre-mixed PC reduced the potential for nuisance dust.
